**Flood Control Project Maintenance
Levee Inspections**

Maintenance Issue Types Only, Levee Inspection Report By Mile - Spring 2018

Reclamation District No. 0369 Libby McNeil

Waterway	Bank	Unit Miles	Inspection Start/End	Inspector
Unit No. 01 Sacramento River	Left	0.78	03/21/2018 03/21/2018	Keith Millard

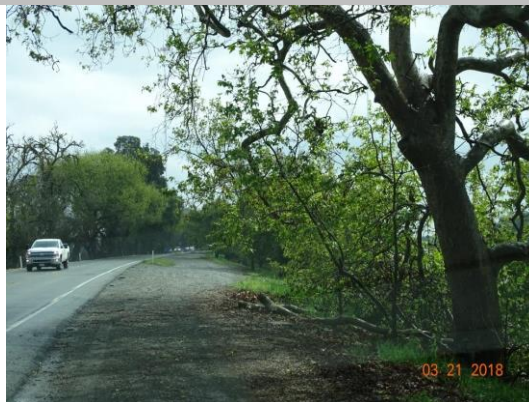
Photo 1 of 1 : SP_2018_RD0369_207_12_20180322_00025.jpg

LM Start	0.15	Rating **	M	Issue No.	12
LM End	0.15	Issue Type +	Ma	Location *	WS
Category	Earthen Levee		GPS Latitude/Longitude		
			Start	End	
Item	Encroachments		38.257380 °	38.257380 °	
			-121.515787 °	-121.515787 °	
DWR ID	DWR_RD0369_01_s_2018_12				
Comment Code					
TR : Tree or limb					
Inspector Comment					
Cut tree branches should be removed from waterside shoulder.

Remove tree branches from waterside shoulder.

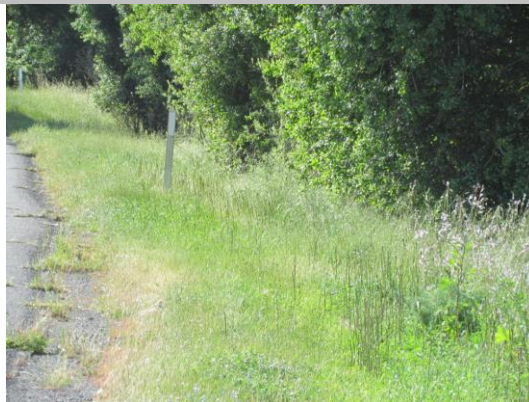
Photo 1 of 1 : SP_2018_RD0369_207_9_20180305_00003.jpg

LM Start	0.25	Rating **	M	Issue No.	9
LM End	0.57	Issue Type +	Ma	Location *	WS
Category	Earthen Levee		GPS Latitude/Longitude		
			Start	End	
Item	Vegetation		38.256372 °	38.252597 °	
			-121.514504 °	-121.511130 °	
DWR ID	DWR_RD0369_01_s_2017_9				
Comment Code					
V2 : Remove the wild growth other than native grasses from the levee slopes.					
Inspector Comment					
Spray the weed growth along the waterside slope to 20' from crown.

Looking downstream from the waterside shoulder.

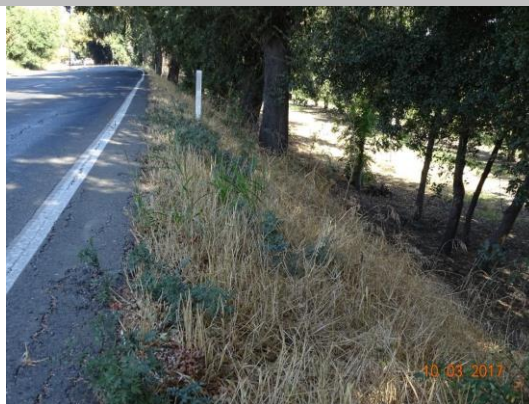
Photo 1 of 1 : SP_2018_RD0369_207_13_20180305_00006.jpg

LM Start	0.26	Rating **	A/W	Issue No.	13
LM End	0.32	Issue Type +	Ma	Location *	LS
Category	Earthen Levee			GPS Latitude/Longitude	
				Start	End
Item	Trim / Thin Trees			38.256222 °	38.255659 °
				-121.514320 °	-121.513706 °
DWR ID	DWR_RD0369_01_f_2016_13				
Comment Code					
T2 : Thin trees to allow visibility of the ground and room to flood fight.					
Inspector Comment					
Thin out the tree growth along the landside slope.

10/03/2017: Vines and low branches and heavy weed growth have been removed. Visibility and access are improved.
